SmartEQ Pro+ with Go2Nova[®] 8408 Hand Controller Firmware Upgrade

The firmware of a SmartEQ Pro+ main board and Go2Nova[®] 8408 hand controller can be upgraded by a customer. Please check iOptron's website, www.iOptron.com, under **Support**, for the most up to date firmware.

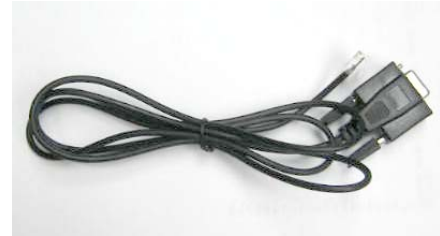
RS232 to RJ9 serial cable

The firmware upgrade and computer controller is through a RJ9 serial port on a Go2Nova[®] 8408 hand controller. You need a cable to connect this port to the serial port of a computer. Here is a sample of a RS232 to RJ9 serial cable. **Please do not use other brand cable other than iOptron. They may look exactly same but wired differently.**

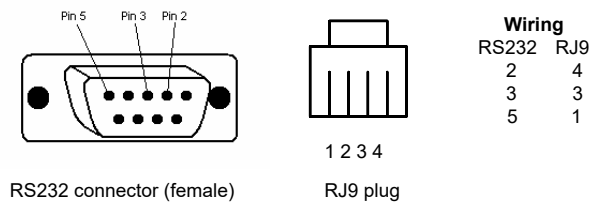
If you are making your own cable, here is the wiring instruction:

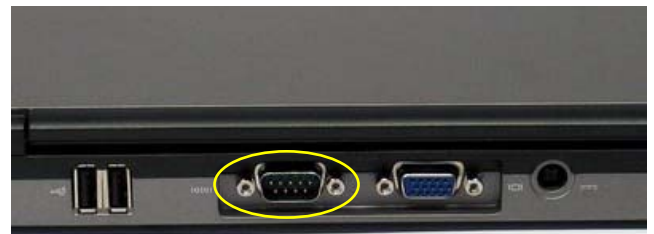
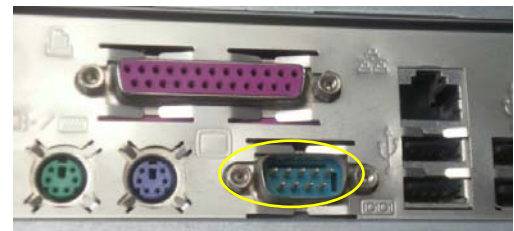
Serial (RS232) Port on a Computer

The first step is to find if your computer has a serial port (or RS232 port). The following photos show a native (built-in) serial port on a laptop (left) and a desk top (right). It is a 9-pin D-shaped (DB9) connector. The assigned port number usually is COM1. Minimum 5.0V DC output power at serial connector is needed to ensure reliable data transmission. **If you have difficult to upgrade main board firmware with native RS232 port, use a USB-RS232 converter.**

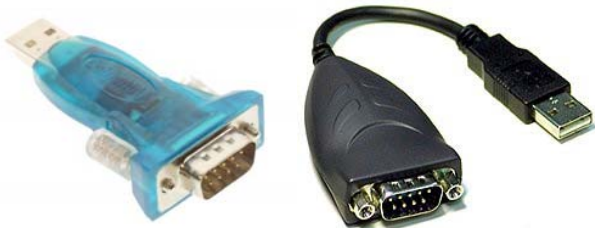
USB to RS232 converter

If your computer only has USB ports, like most late PC and laptops do, or the native RS232 port does not perform, you need a USB to COM (RS232) converter to convert one USB port to a RS232 port. Here are two examples of USB2COM converters. Here are two examples of USB2COM converters. We recommend having a converter that uses high quality chipset, such as one from FTDI or Silicon Labs, to ensure a reliable operation.

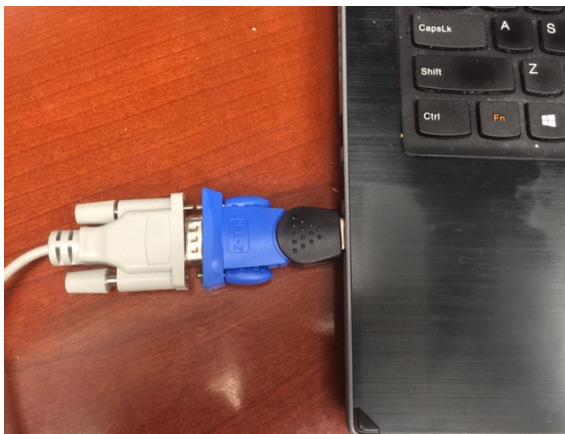
Set up you mount. Connect the hand controller to the HBX socket on the SmartEQ Pro+ mount (**NOT the GUIDE socket!**)

Plug the USB to RS232 converter into one of available USB port and connect the RS232-RJ9 serial cable onto the serial port of the converter.

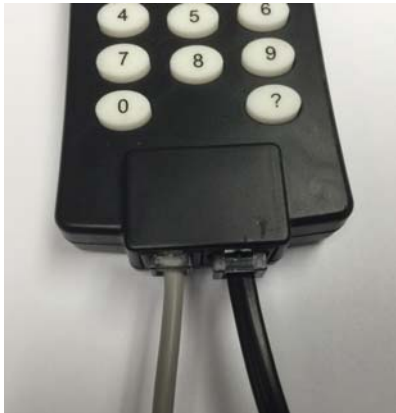
- (1) Connect the 8408 hand controller to the HBX port of a SmartEQ Pro+ mount. Make sure the mount power is OFF;
- (2) Connect 4-pin RJ9 plug into the serial port of a 8408 hand controller and the 9-pin RS232 connector to your computer's RS232 port (or RS232 port of the USB2COM converter);

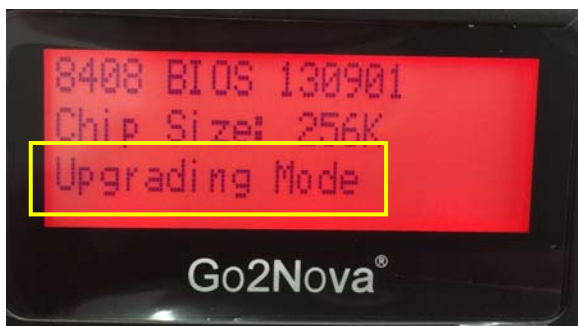
- (3) Hold **ENTER** button of the hand controller while switch the ON/OFF button to turn the mount power on. The hand controller will enter the upgrading mode, such as the following screen:

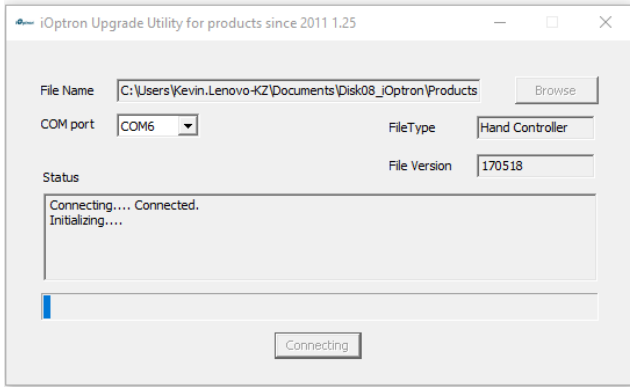
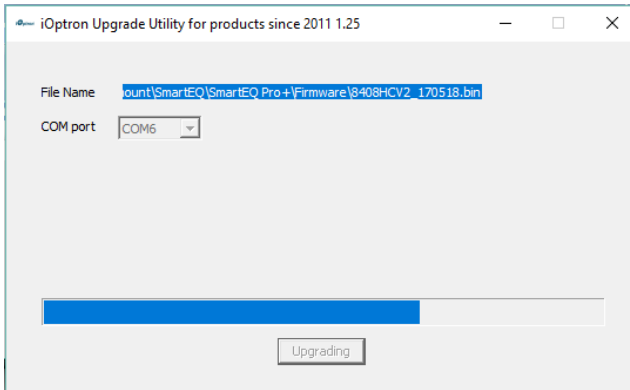
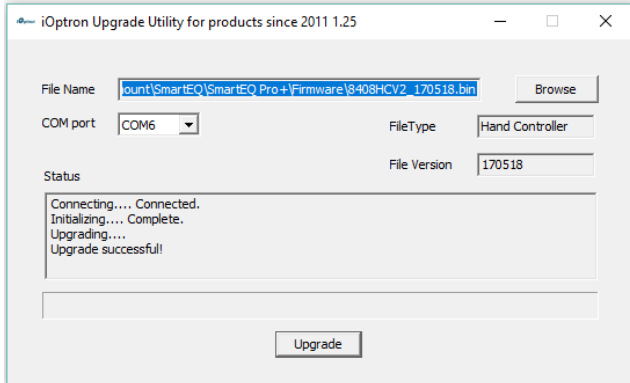
- (7) Click on **Upgrade** button to start the process;
